APPROACHES FOR TENSILE TESTING OF BRAIDED COMPOSITES

Gary D. Roberts and Jonathan A. Salem
NASA Glenn Research Center, Cleveland, Ohio

Braiding approach for composite fan cases

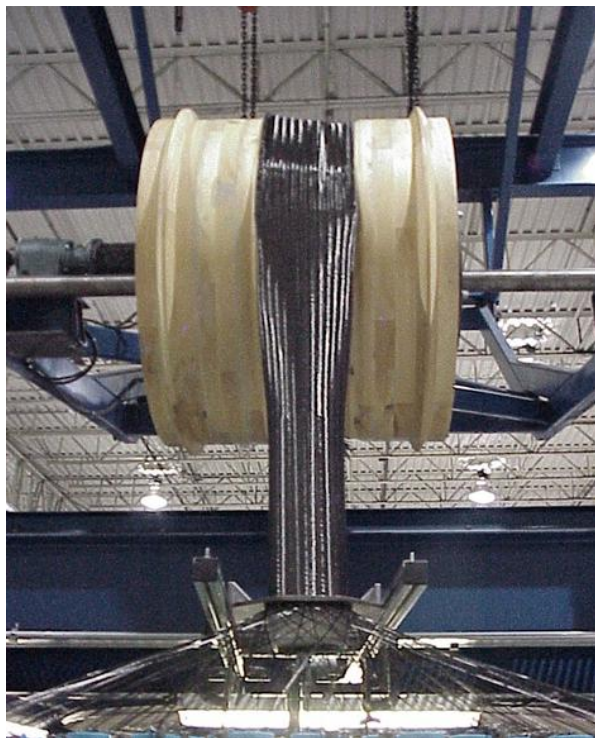
Preform fabrication (A&P Technology, Cincinnati, Ohio)

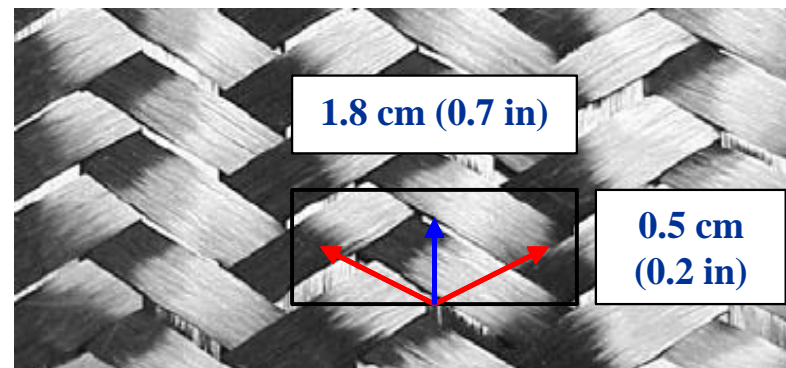
0/+60/-60 braid architecture

- Minimizes interlaminar stresses
 - Reduces delamination
- Increases intralaminar stresses
 - Causes local damage within the unit cell
 - Causes excessive edge damage in straight-sided test coupons

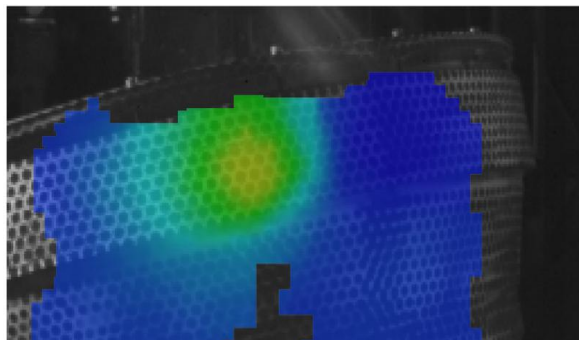
Composite case test

(Out of plane deformation)

- Panel tests simulate deformation and failure in case tests
 - Reference: Roberts et al., 19th ISABE Conference (ISABE 2009) sponsored by the International Society for Air Breathing Engines, Montreal, Canada, September 7-11, 2009. (Also NASA/TM-2009-215811)
- Deformation is measured by digital image correlation (DIC)
- Calculated strain is limited by
 - Camera resolution and frame rate
 - Software settings used for DIC (e.g. facet size and filtering)
- First fiber failure during impact seems to occur at a higher strain than expected based on static test data

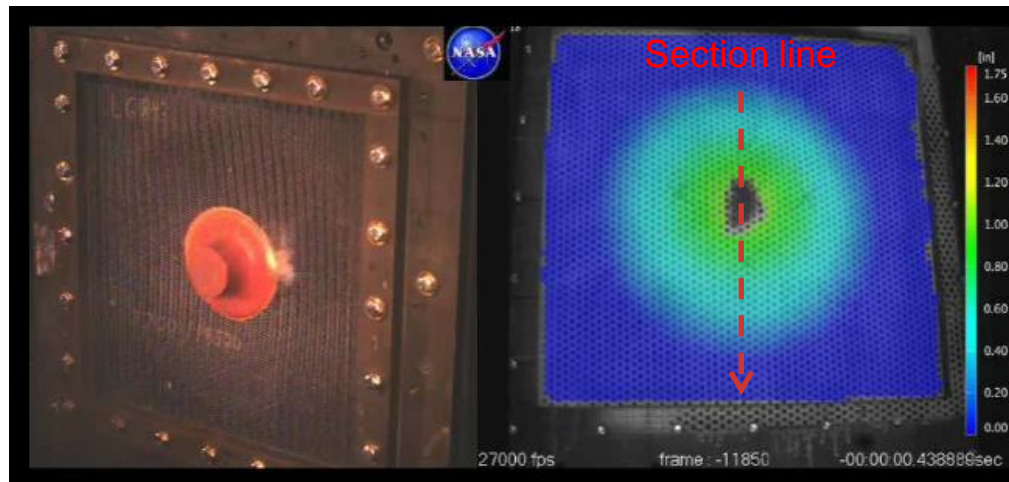
Composite panel test

[2 ft X 2 ft (0.61 m X 0.61 m) panels]

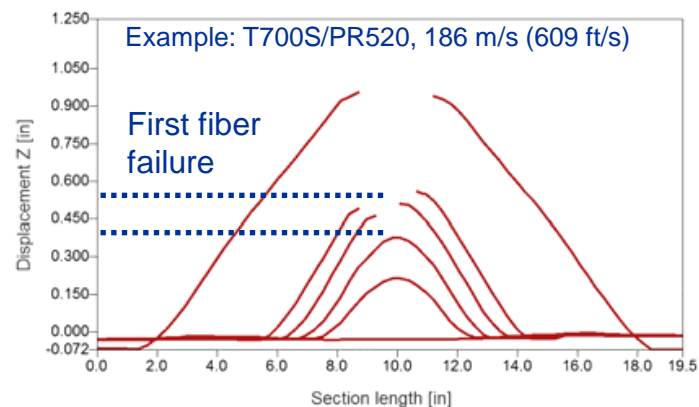
Out of plane displacement along a section line at 37 μ s time steps

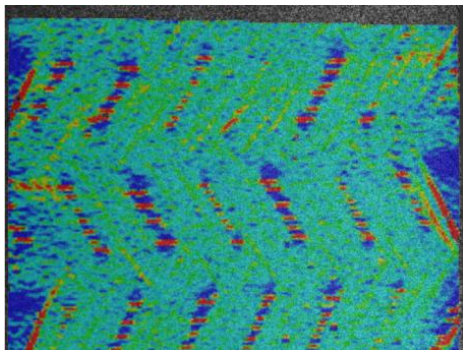
Strain in load direction

Edge damage
(blue regions on edges)

Axial tow splits

- Interior damage is a characteristic of the bulk material
- Edge damage is a result of stresses and unconstrained fiber tows at specimen edges

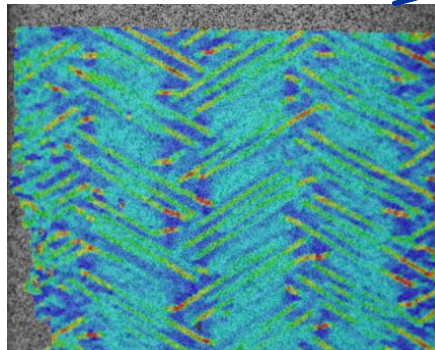
Possible
edge damage

Bias tow splits

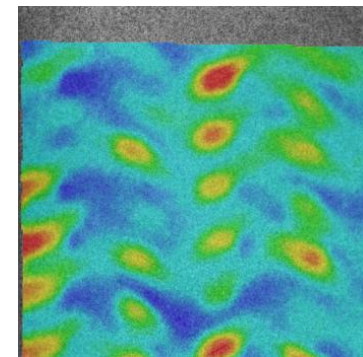
Out-of-plane deformation

Delamination
between tows

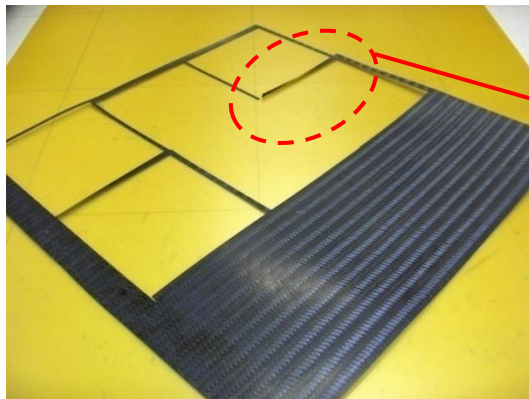
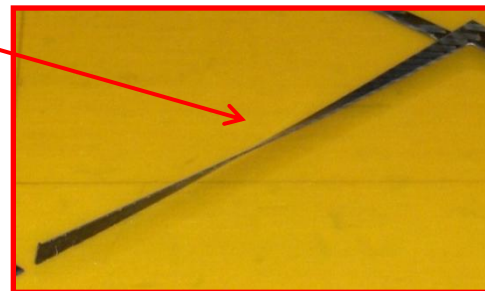
Effect of laminate unbalance at the unit cell level

Flat 2 ft X 2 ft
(0.61m X 0.61m)
panel

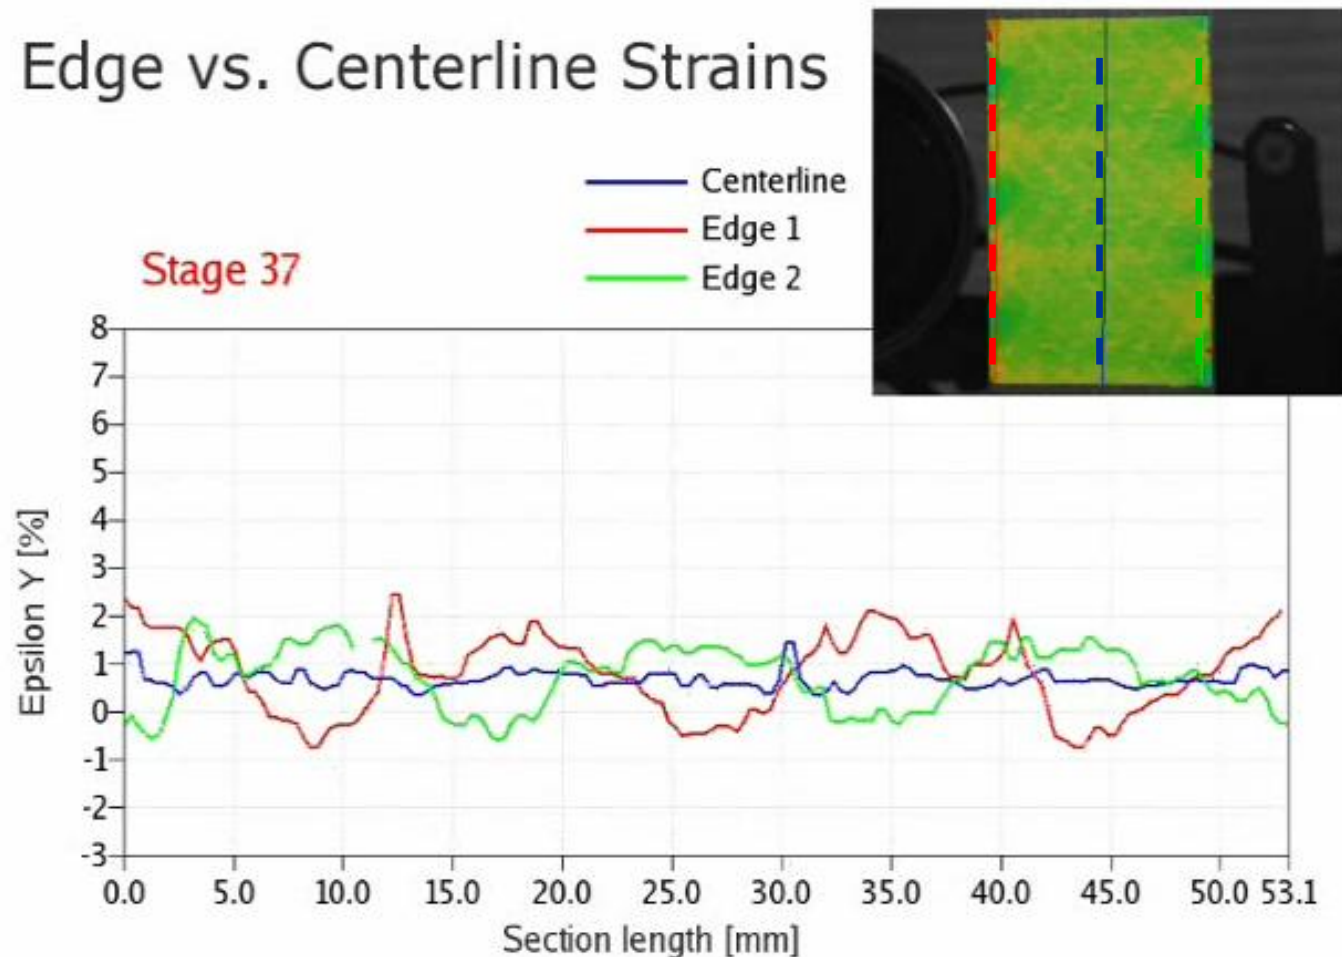
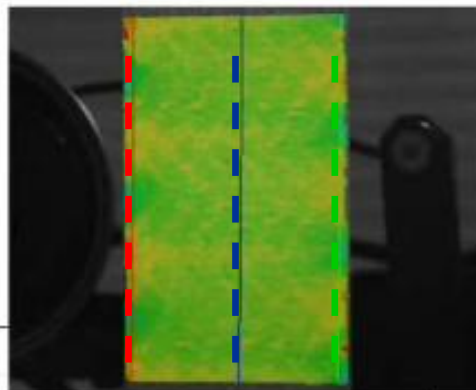
Damage evolution during transverse tensile loading

Edge vs. Centerline Strains

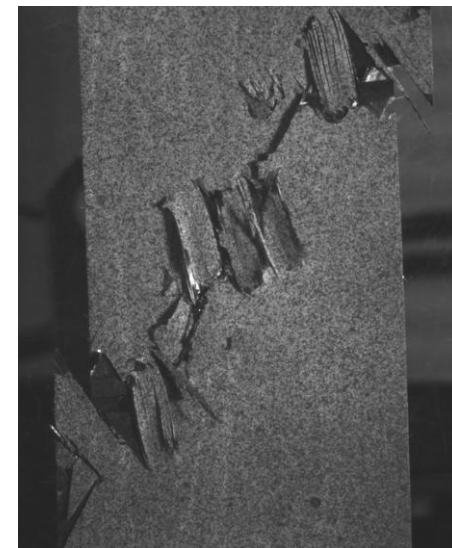
Edge-initiated
shear failure

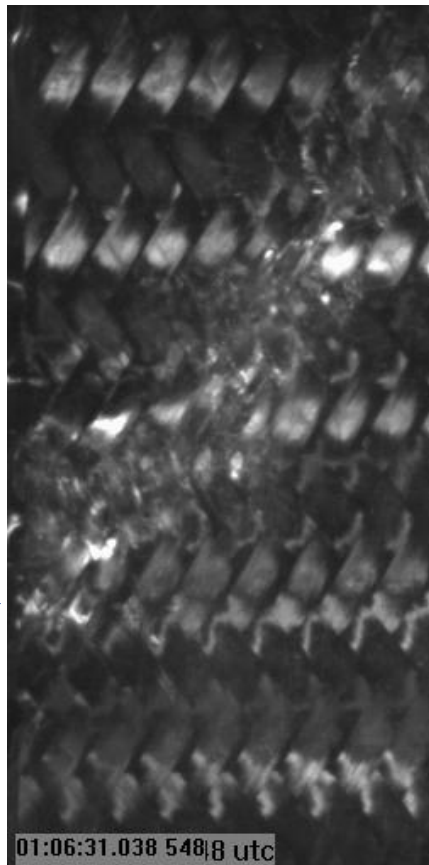
High speed video frames just after failure initiation

Failure
initiation

Transverse loading
(Edge-initiated shear failure)

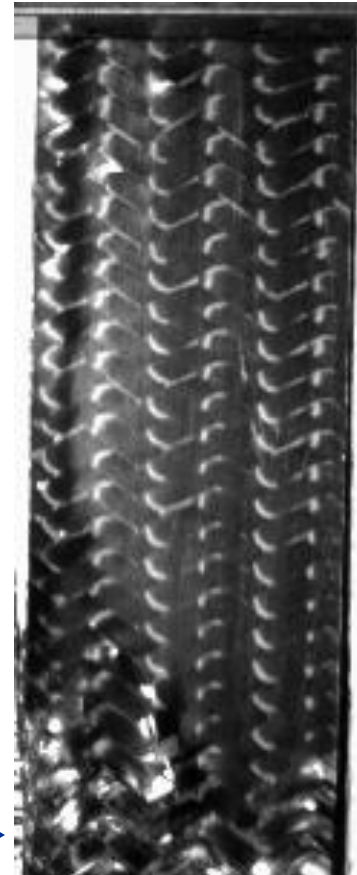
Failure
initiation

Axial loading
(Edge-initiated tensile failure)

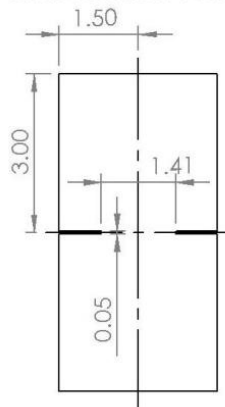
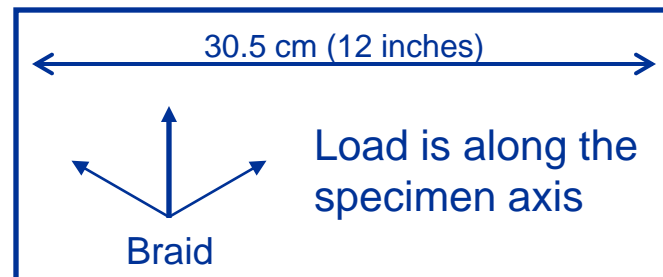
Axial Tension Bowtie

Axial Tension Notch

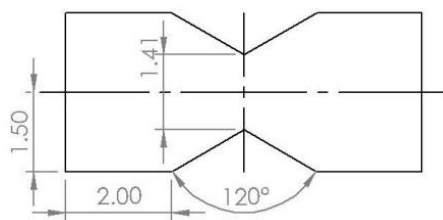
Transverse Tension Bowtie

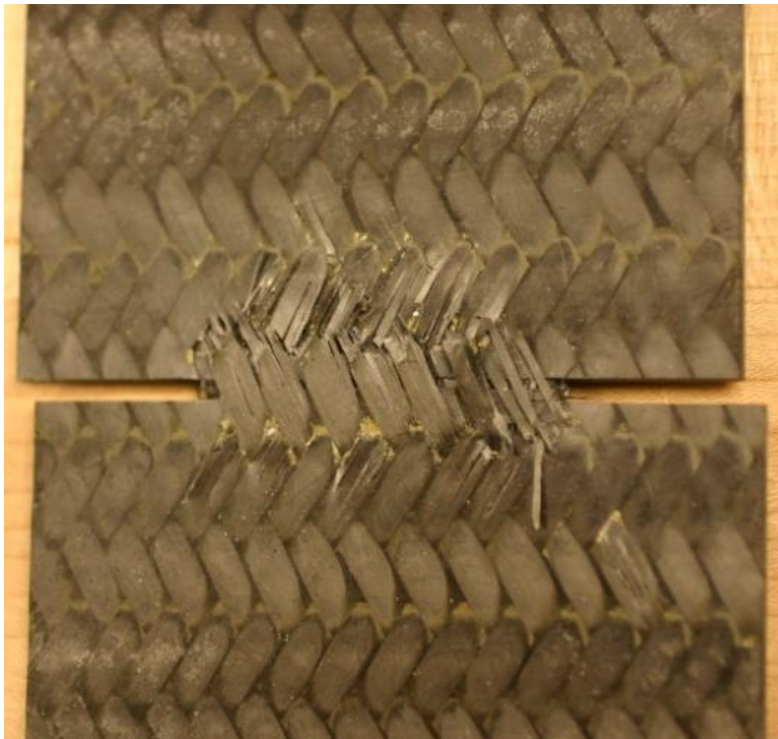
Notched transverse tensile specimen (T700S/E-862 material)

- Tensile failure mode
- No edge damage

- 462 MPa - straight-sided
- 813 MPa - notched

Back of specimen
(DIC measurements are made on front of specimen)

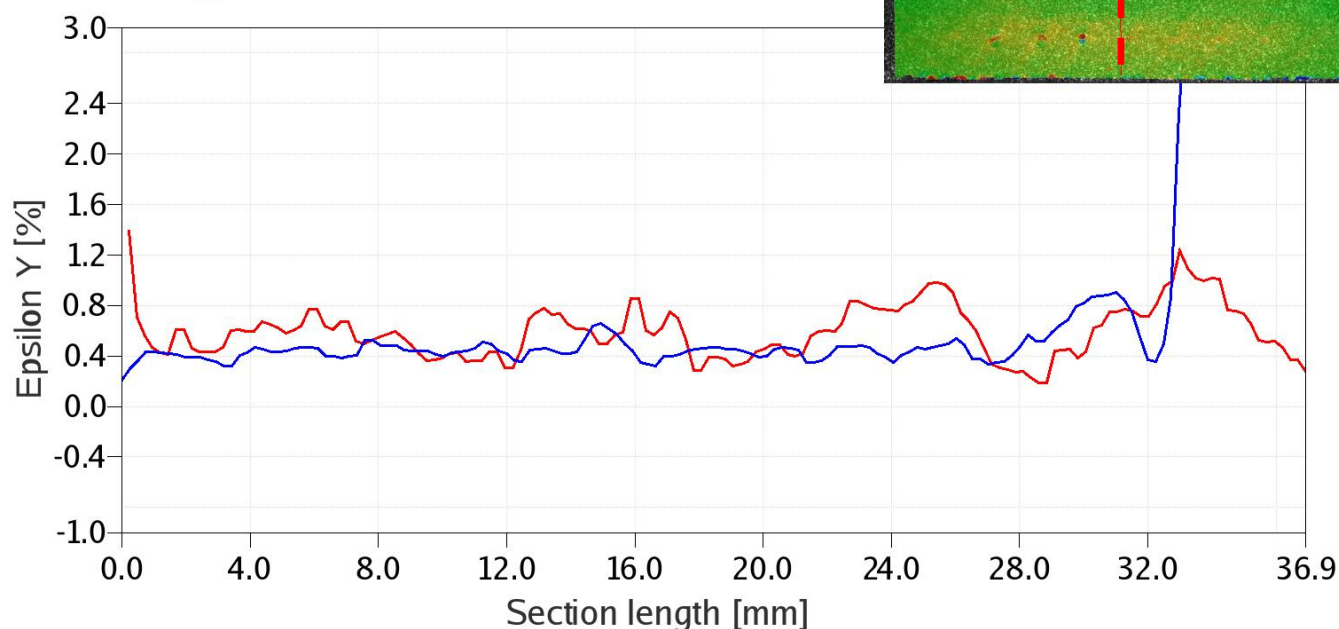
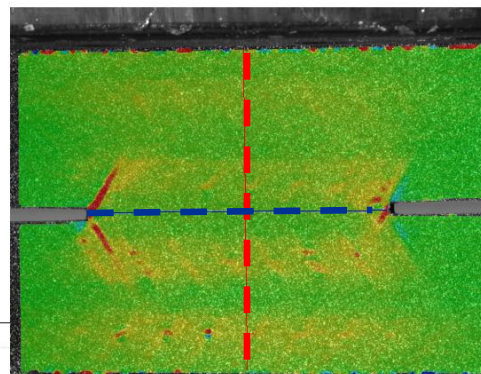
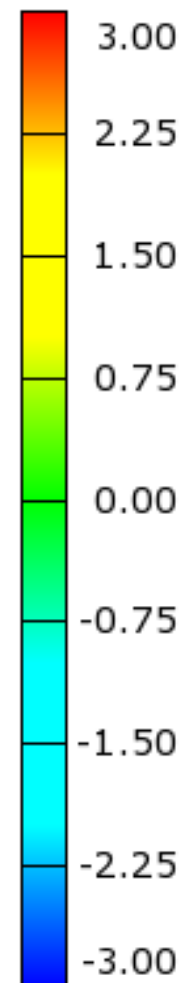
Notched transverse tensile specimen (Vertical strain)

351 MPa
Stage 64

Section lines
— Horizontal
— Vertical

Vertical strain
(Front of specimen)

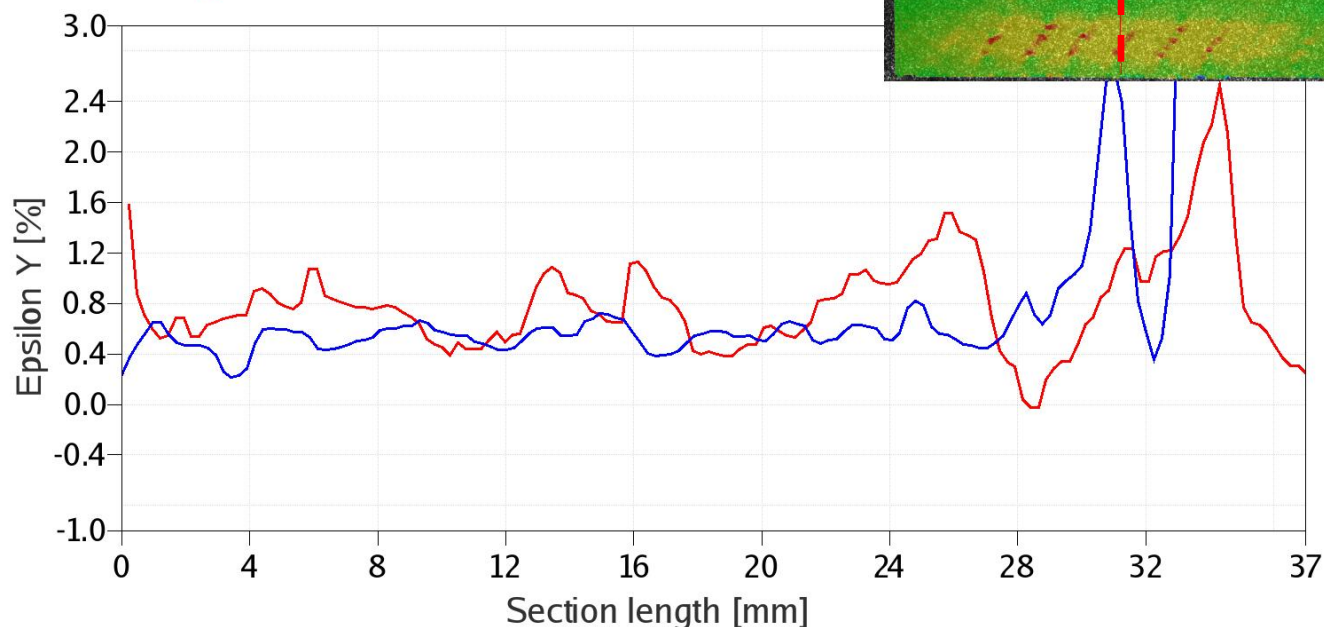
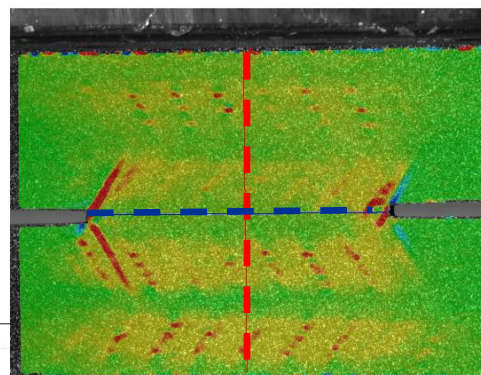
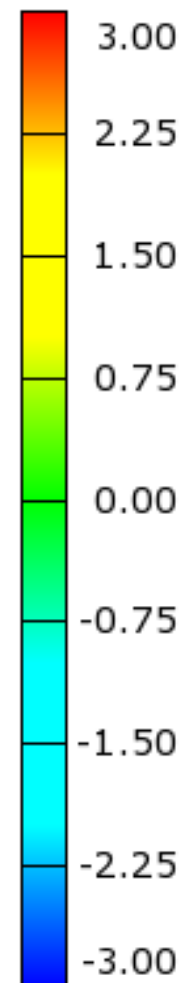
Notched transverse tensile specimen (Vertical strain)

451 MPa
Stage 85

Section lines
— Horizontal
— Vertical

Vertical strain
(Front of specimen)

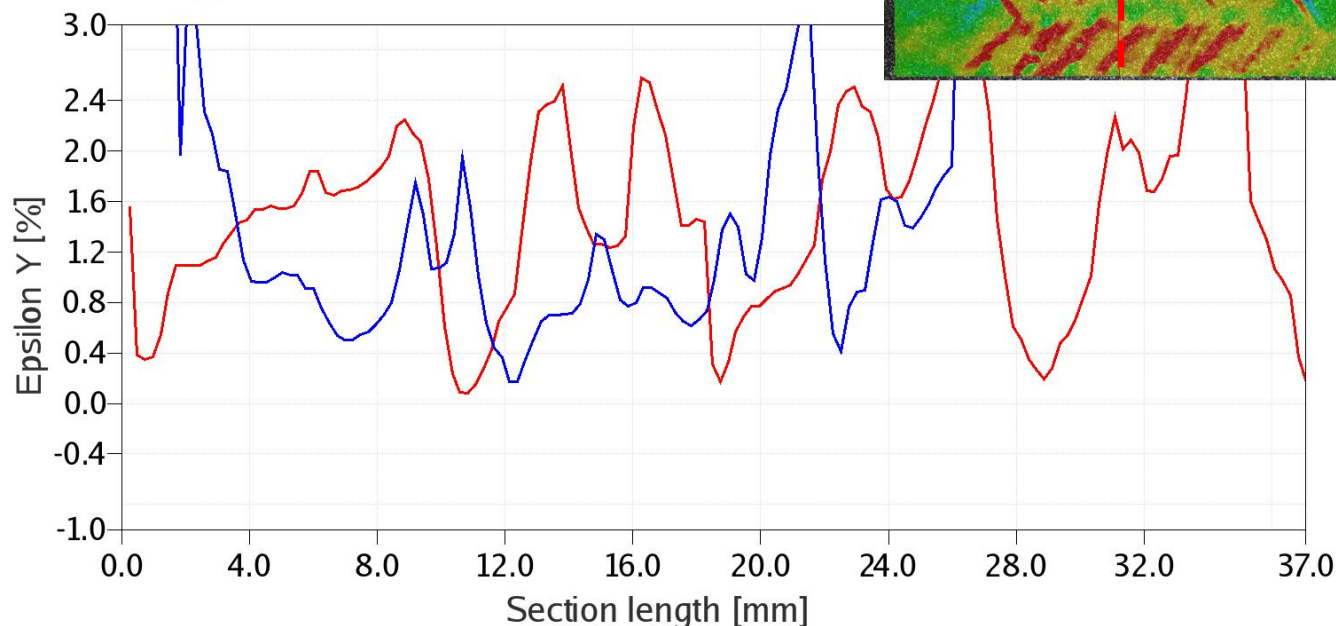
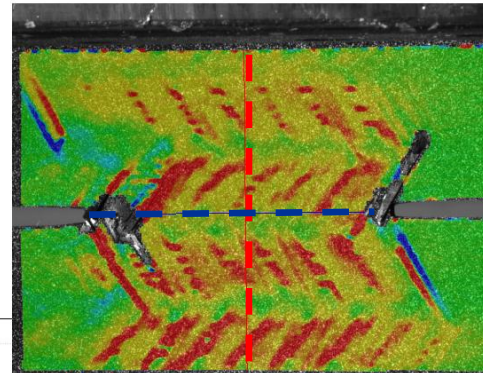
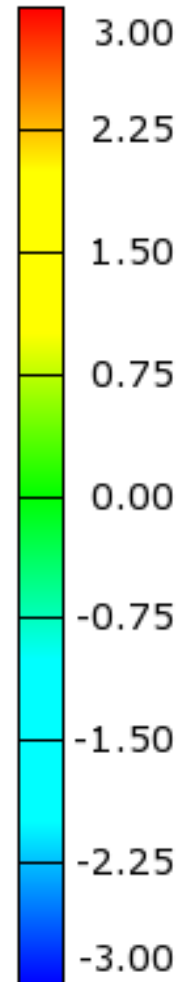
Notched transverse tensile specimen (Vertical strain)

729 MPa
Stage 162

Section lines
— Horizontal
— Vertical

Vertical strain
(Front of specimen)

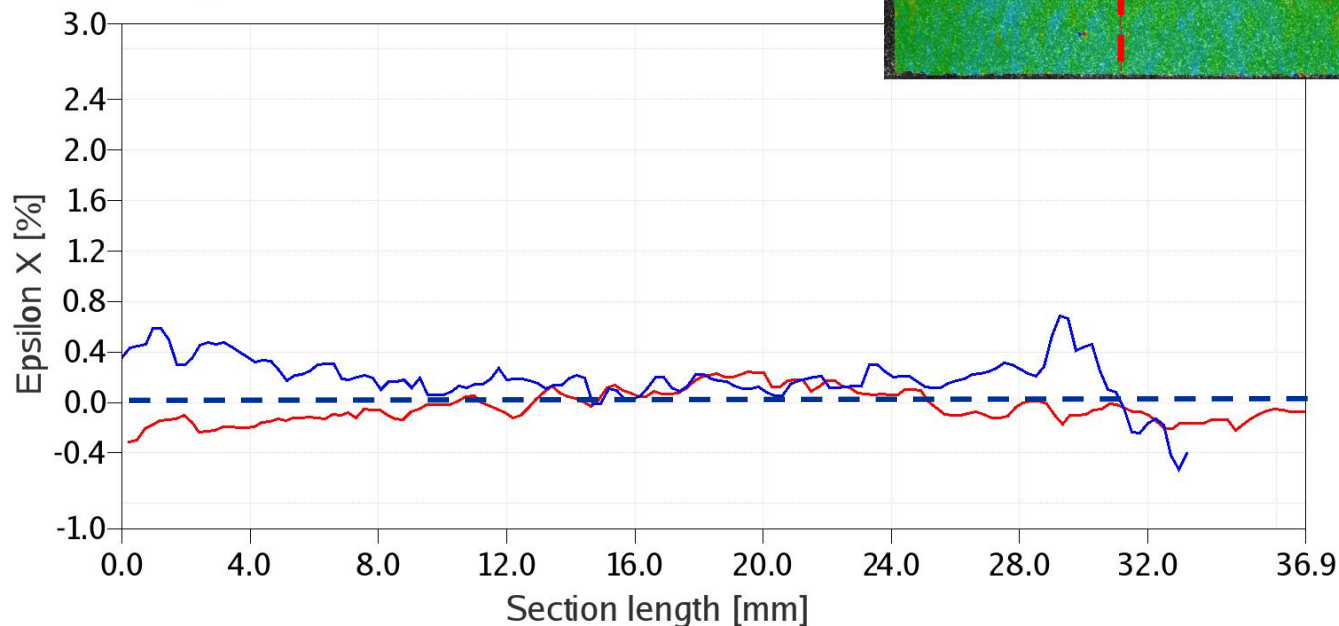
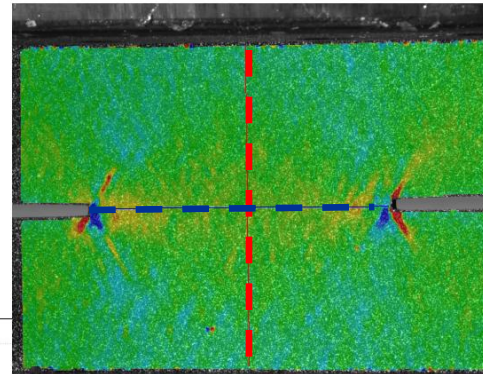
Notched transverse tensile specimen (Horizontal strain)

351 MPa
Stage 64

Section lines
— Horizontal
— Vertical

Horizontal strain
(Front of specimen)

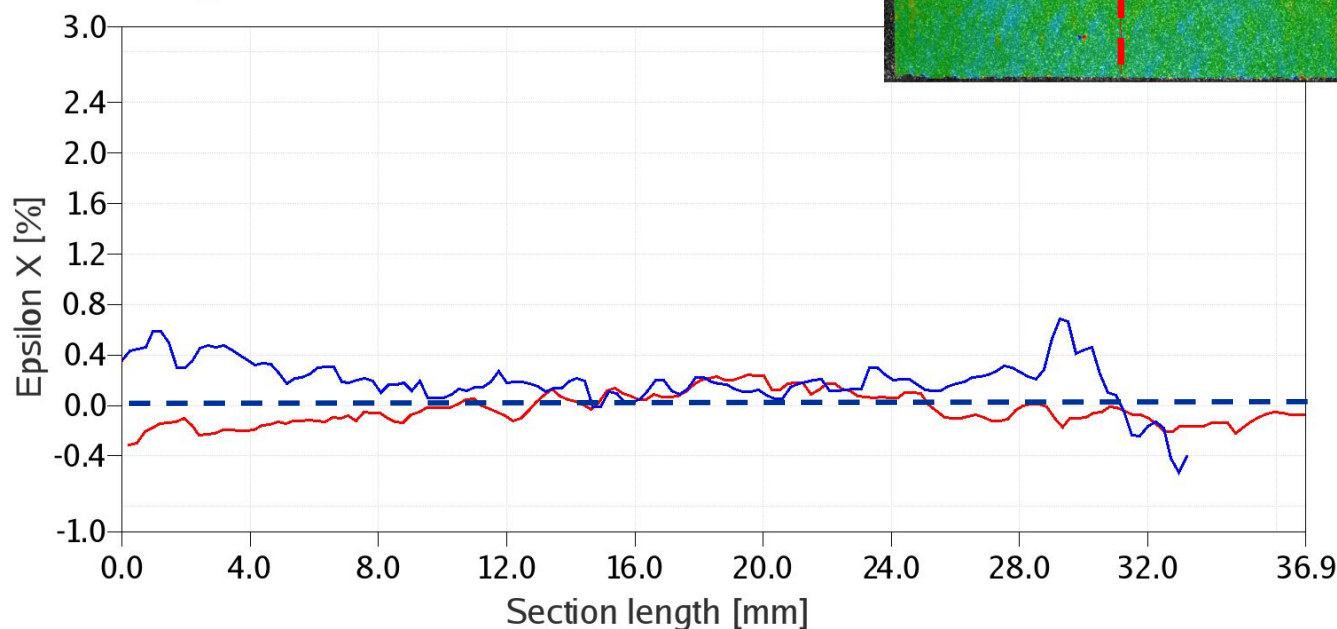
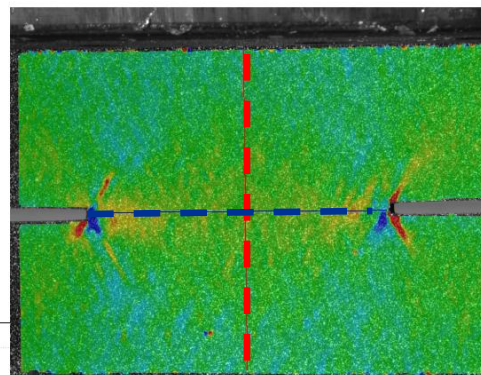
Notched transverse tensile specimen (Horizontal strain)

351 MPa
Stage 64

Section lines
— Horizontal
— Vertical

Horizontal strain
(Front of specimen)

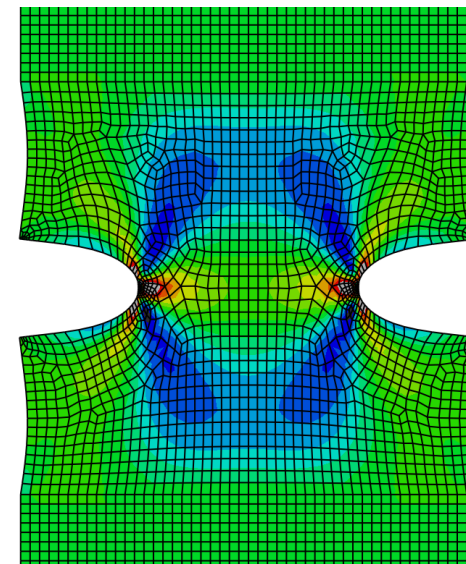
FE simulation
(Aluminum)

E, E11
SNEG, (fraction = -1.0)
(Avg: 75%)

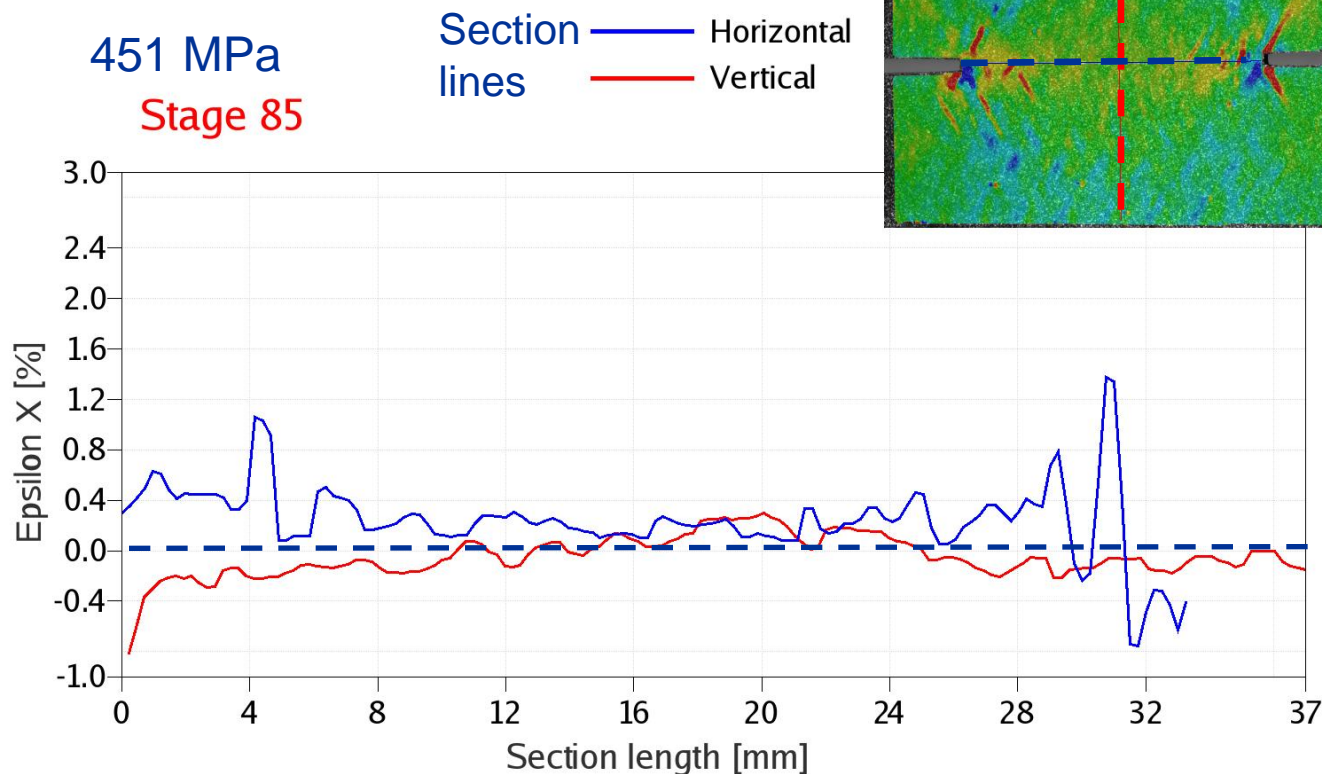
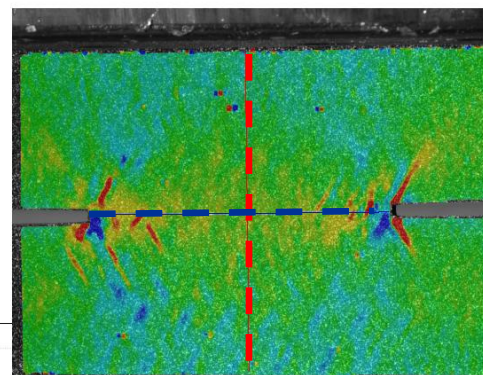
Notched transverse tensile specimen (Horizontal strain)

Horizontal strain (Front of specimen)

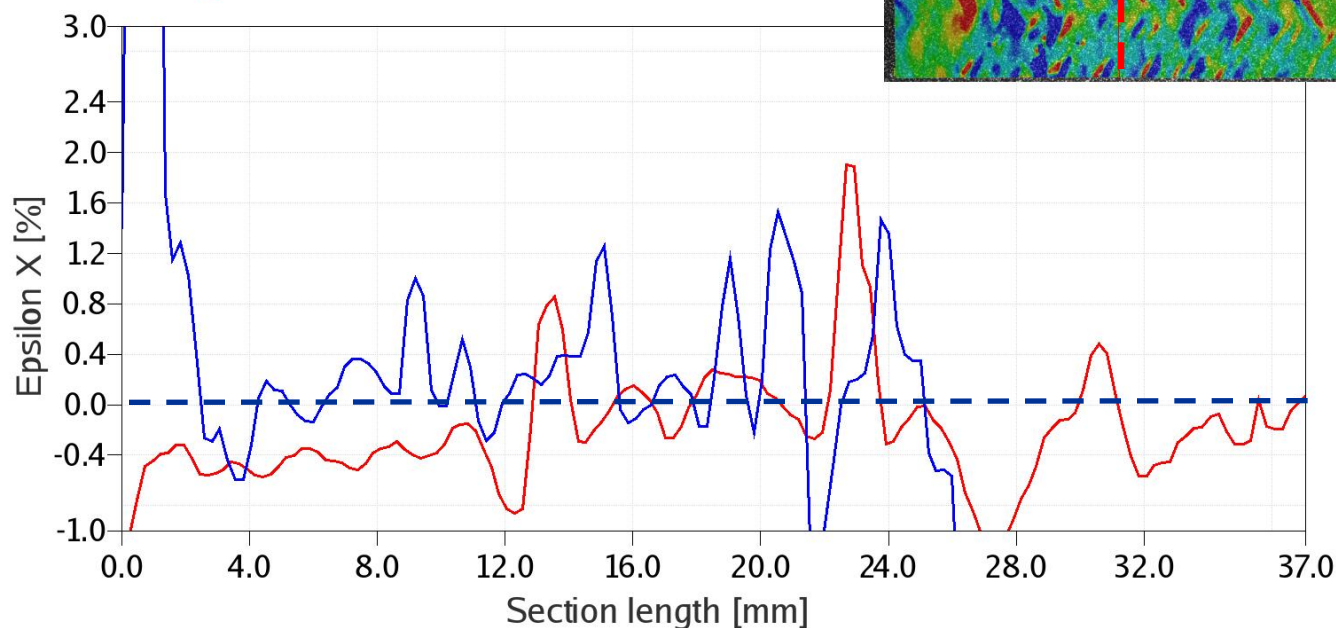
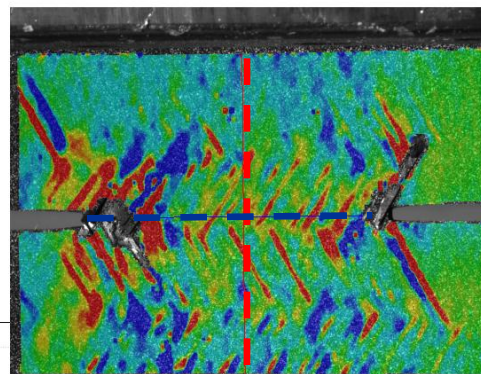
Notched transverse tensile specimen (Horizontal strain)

729 MPa

Stage 162

Section lines
— Horizontal
— Vertical

Horizontal strain
(Front of specimen)

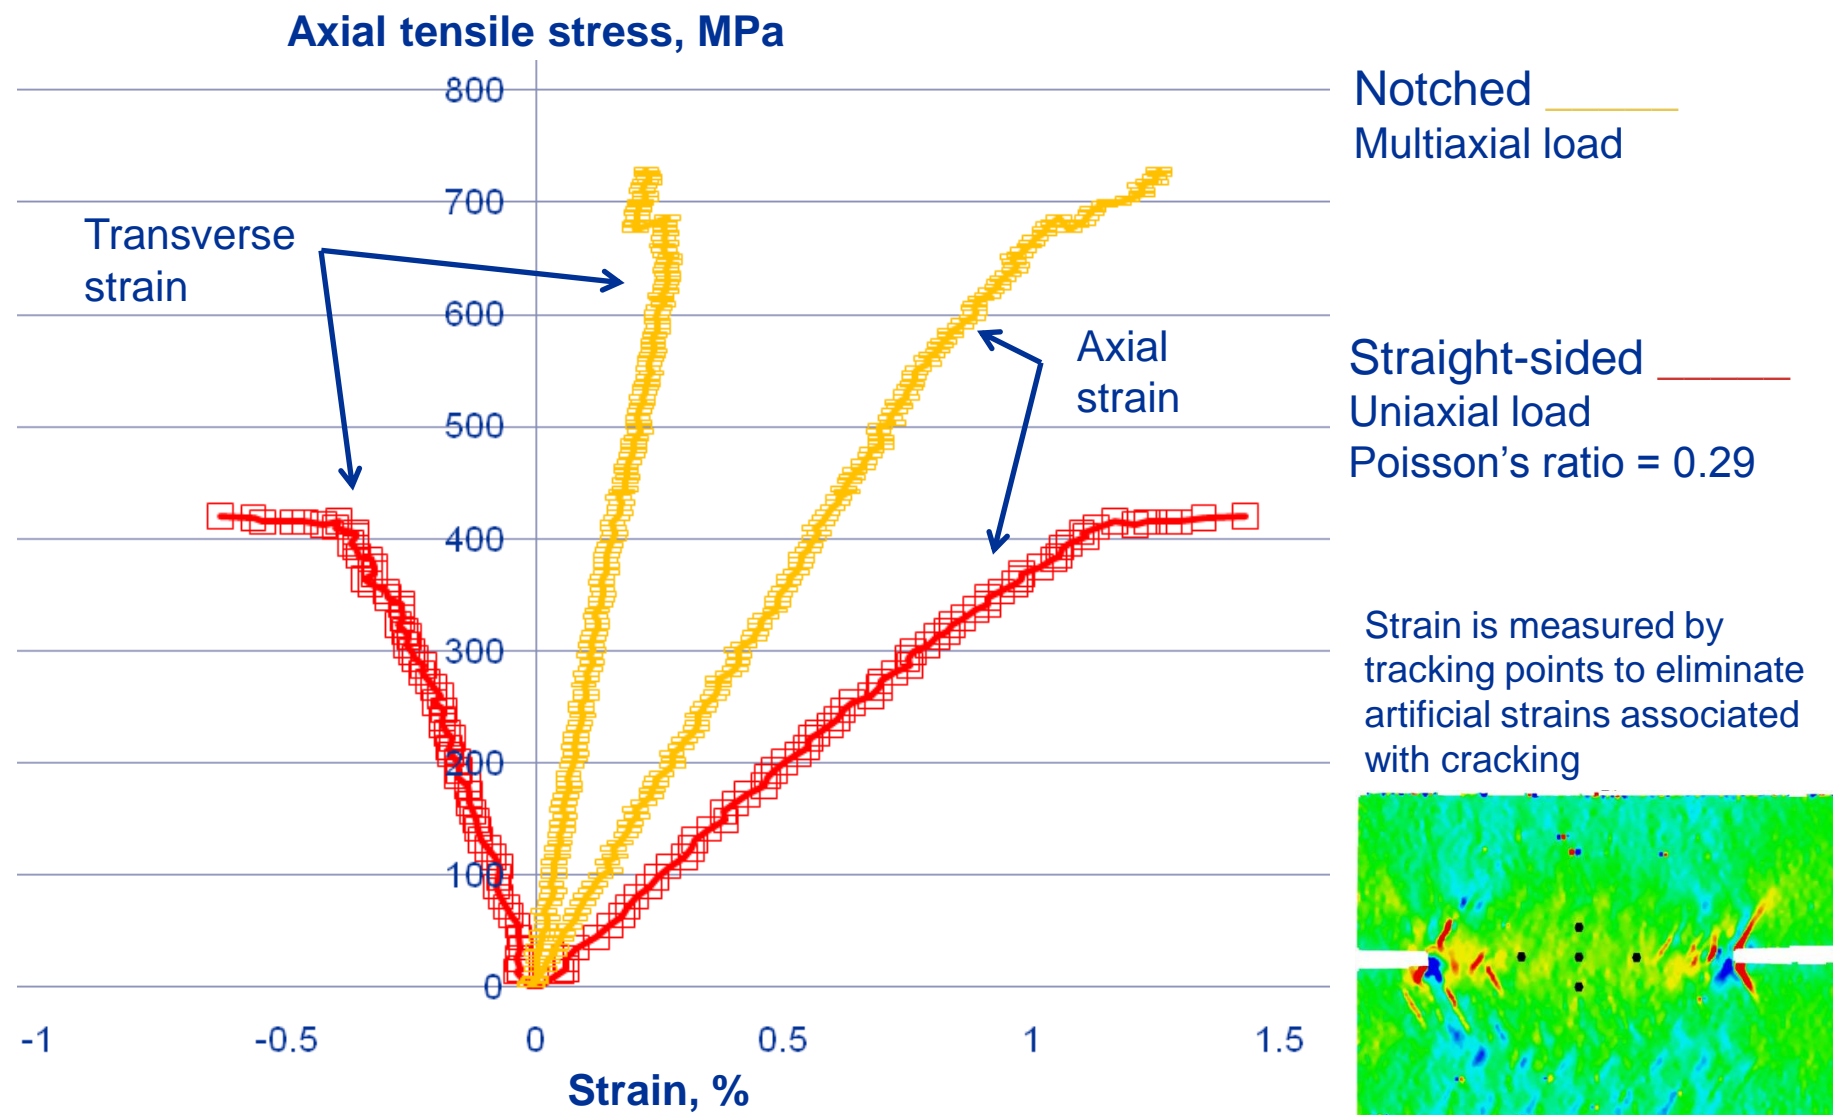
Straight-sided vs notched stress-strain curves

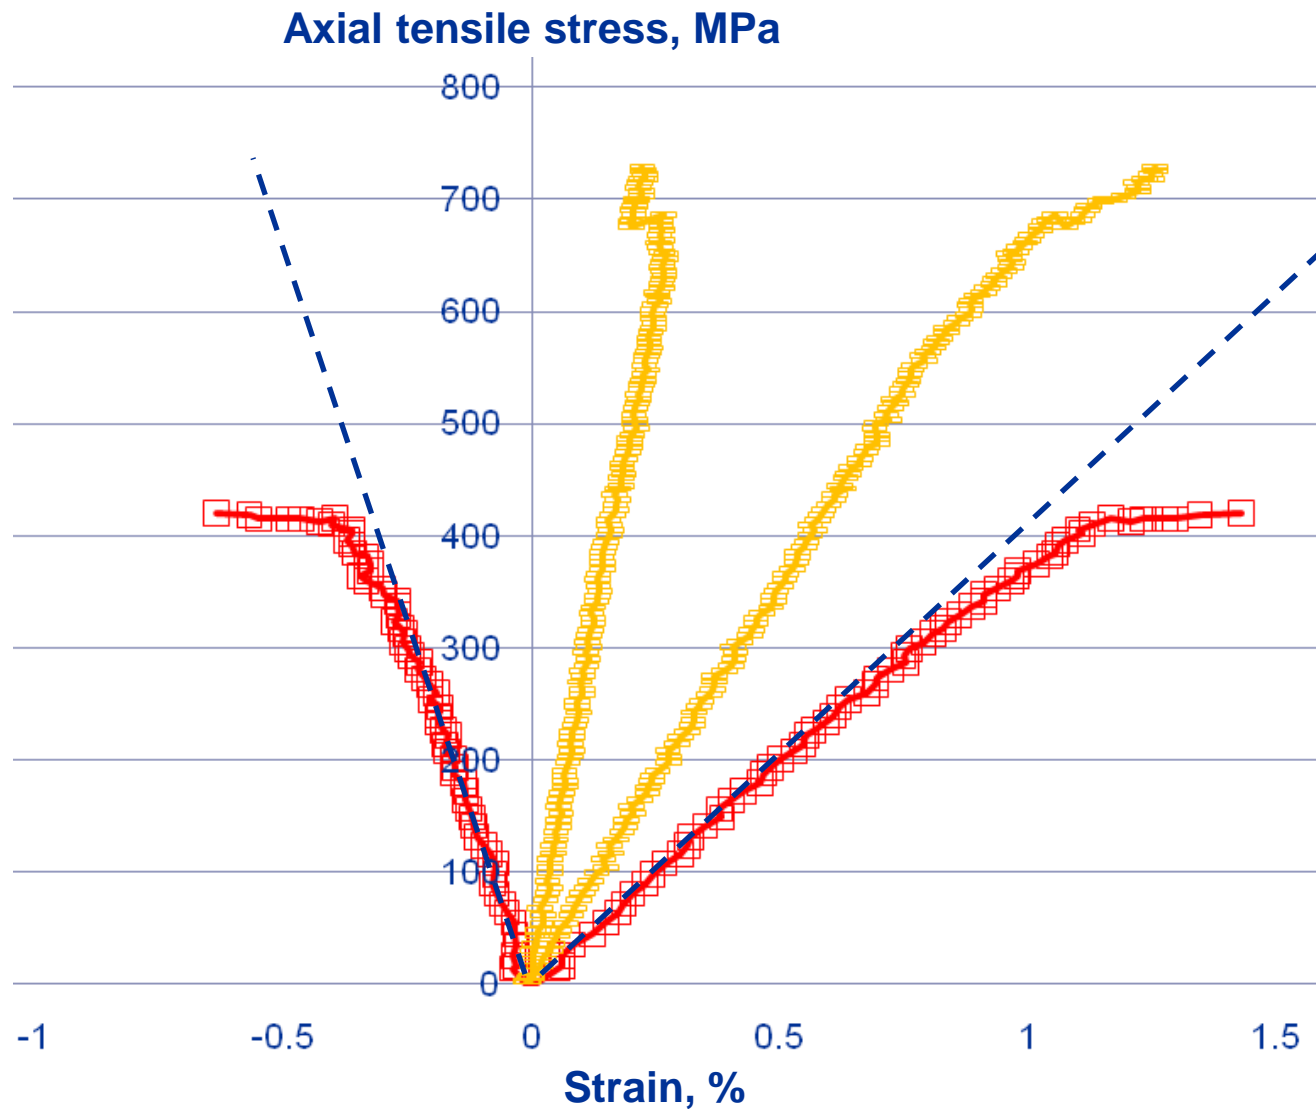
Straight-sided vs notched stress-strain curves

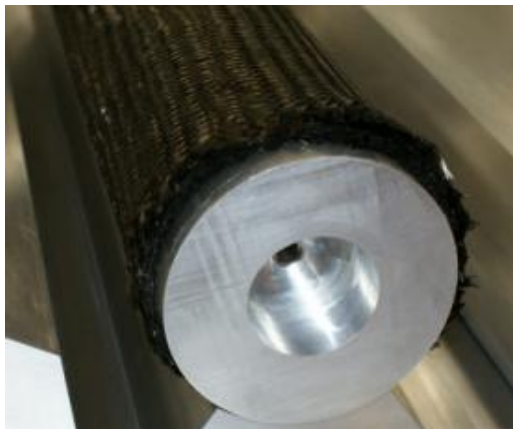
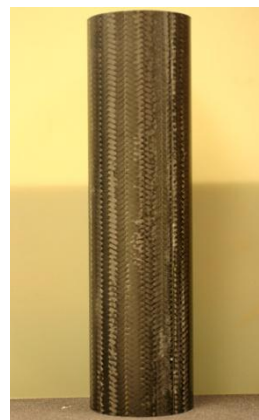
Fabrication by resin transfer molding (RTM)

Preform overbraided on a mandrel

- Diameter: 3.9 in (9.9 cm)
- Wall thickness: 0.125 in (3.2 mm)
- Length: 24 in (61 cm)

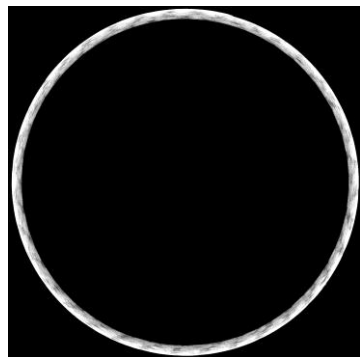
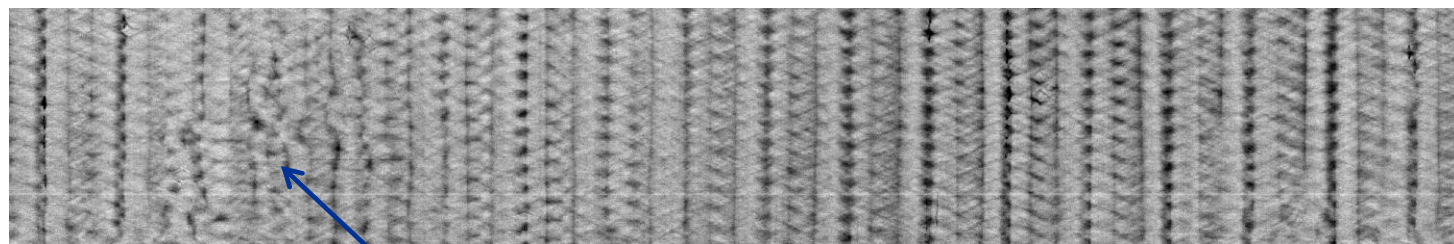
Data is collected as a series of cross-sections

“Unwrapped” CT image shows fiber architecture in individual plies

Local distortion of the preform can be detected

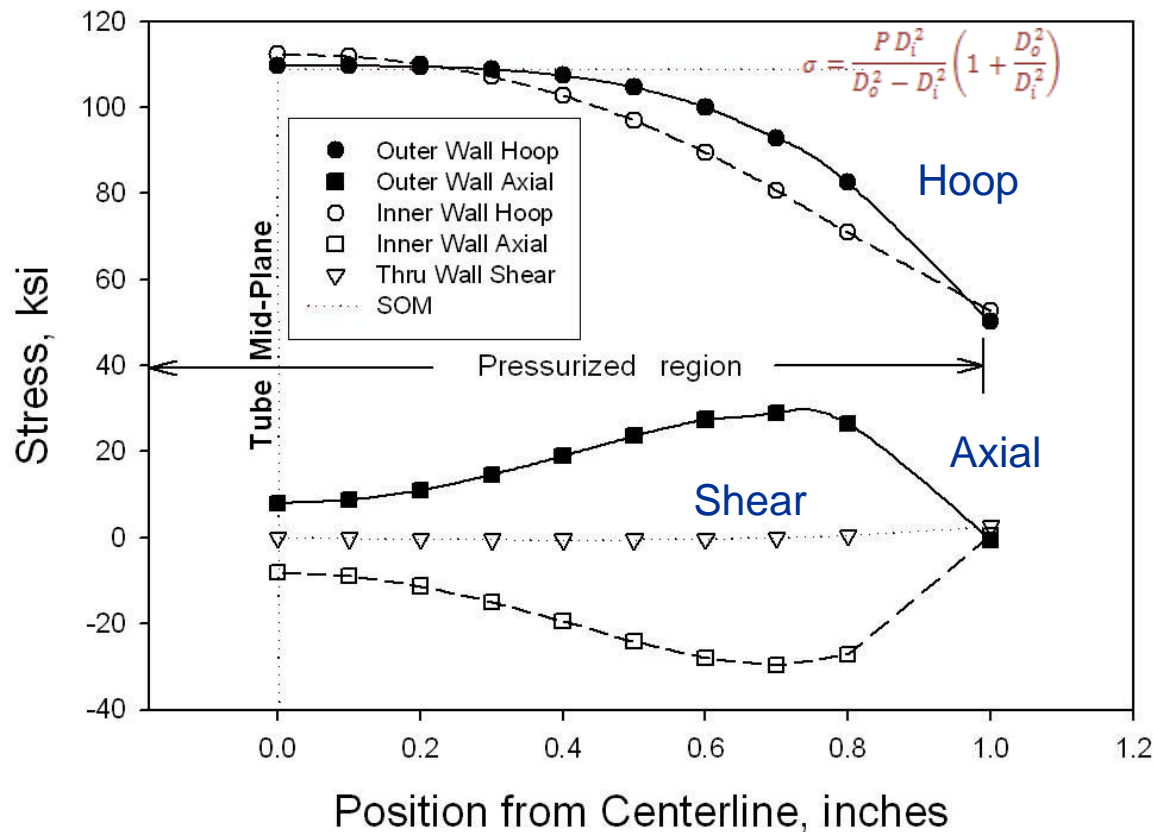
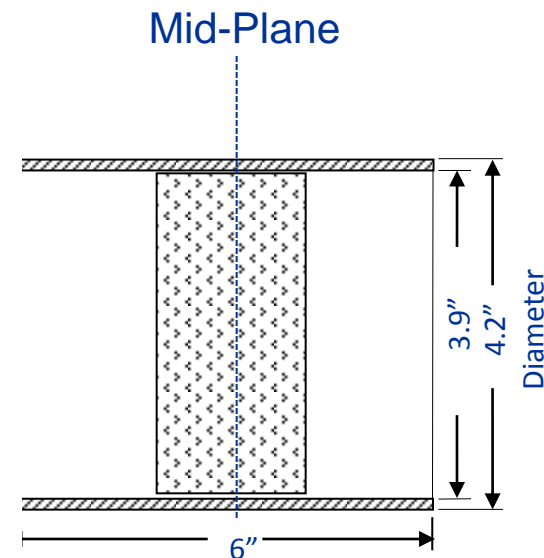
Stresses in a 6 inch tube with 2 inch pressure zone

(Isotropic, homogeneous material with composite material modulus)

- Peak stress occurs near the mid-plane
- Small edge stress reduces the chance of edge initiated failure
- Mid-plane stress state is multiaxial with a dominant hoop stress (transverse tensile)

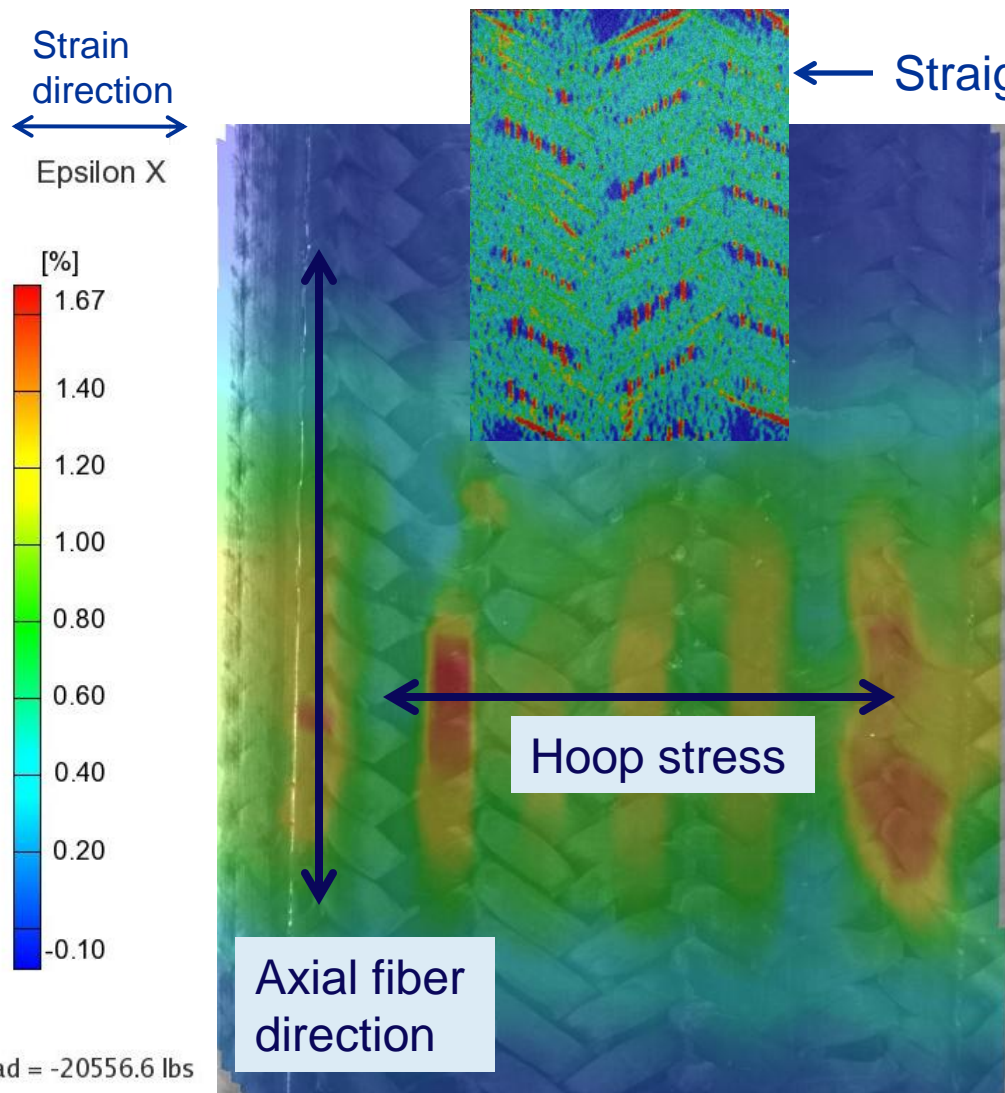
Strain measurement during partial internal pressurization

← Straight-sided transverse tensile coupon

← Tube with internal pressurization

- Hoop stress = 449 MPa (65.2 ksi)

- Tube (hoop) = 786 Mpa (114 ksi)
- Straight-sided coupon = 462 MPa (67 ksi)

- Apparent high strain regions are likely micro-damage viewed at lower resolution
- More accurate strain measurement procedures are being developed for composite tubes
